RE: San Miguel Electric Coop, Inc.
San Miguel Mine, Permit No. 11G
Final Action Notification, NOV 114A

Statement of Inspector's Observations
Notice of Violation No. 114A
Issued to San Miguel Electrical Cooperative, Inc.
San Miguel Mine, Permit No. 11G

COAL MINE INSPECTION REPORT

Inspectable Unit Name: San Miguel Area A&E Permit Number: 11G
 Permittee: San Miguel Electrical Cooperative Inc (SMECI) County: Atascosa and McMullen
 Industry Representative(s) Present: N/A
 Inspector: Jacob Eickstead Date of Inspection: March 17-18, 2015

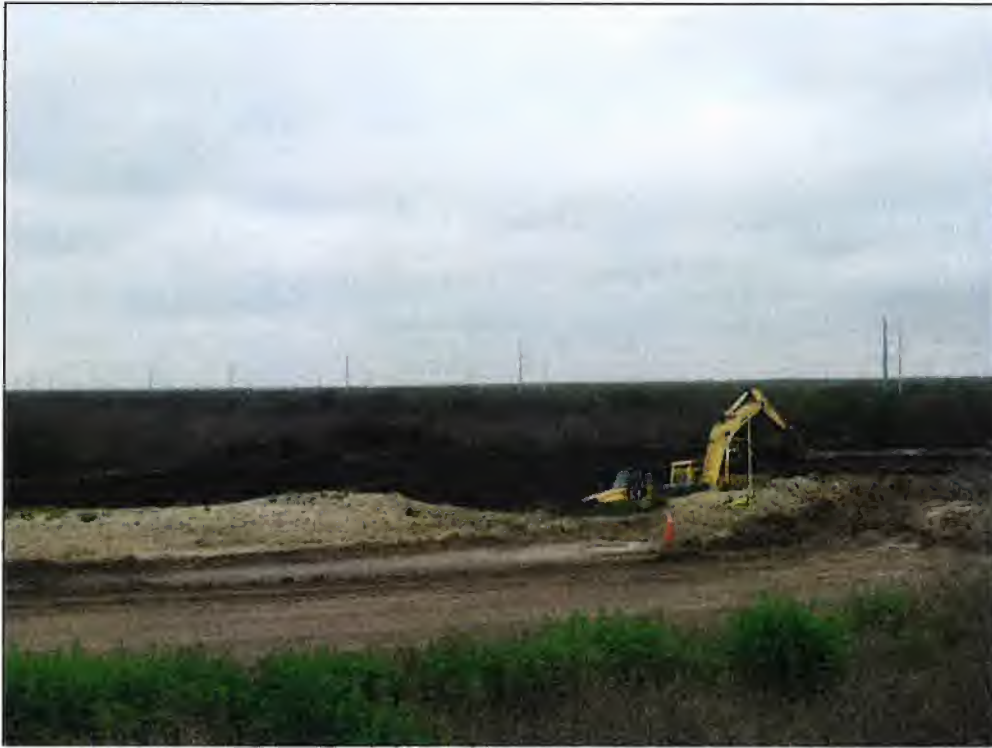
On March 17-18, 2015 I inspected the area affected by the off permit sediment deposition. The affected area is located approximately 2400 feet south of the one lane bridge over La Parita Creek and west of the main haul road (photo 1). The sediment deposition occurred due to failure to maintain the sump on the bottom of Drop Structure No. BN-2 (photo 2). A front end loader was removing the remaining sediment from the affected area using an end dump truck to stage the sediment on the haulroad north of La Parita Creek (photo 3 and 4). The sediment appeared to be composed mostly of haulroad fines which had collected in the sump below Drop Structure No. BN-2 and were deposited north of the haulroad when the sump failed due to lack of maintenance (photo 5). The sediment affected an area of approximately 1.6 acres north of the haulroad (photo 6). The vegetation was removed by dozer and stacked on the western side of the affected area (photo 7).

Photo 1. Affected area located west of the main haul road (view northwest).

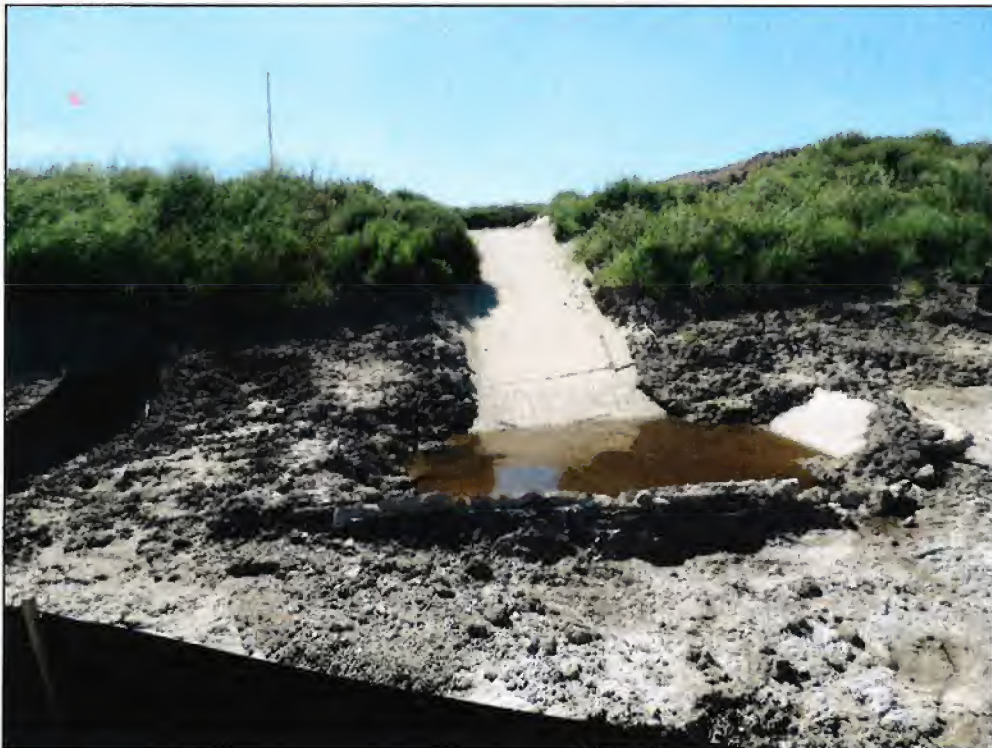
Upon review of the Regulations, Permit No. 11G and discussion with I&E Manager, Notice of Violation 114A was issued to SMECI for failure to maintain appropriate sediment control measures at the sump below Drop Structure No. BN-2. This is a violation of Texas Coal mining Regulations Title 16, Texas Administrative Code §12.343 and section .154 of Permit No. 11G.

Photo 2. Drop Structure No. DN-2 (view southeast).

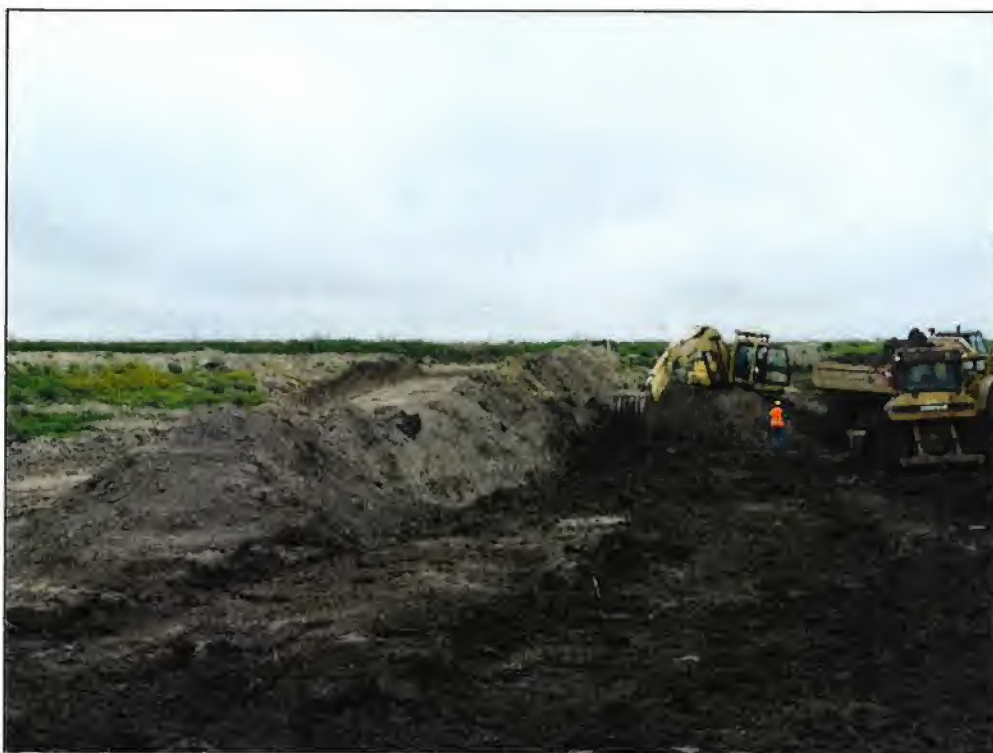
Photo 3. Front end loader removing sediment from affected area (view southwest).

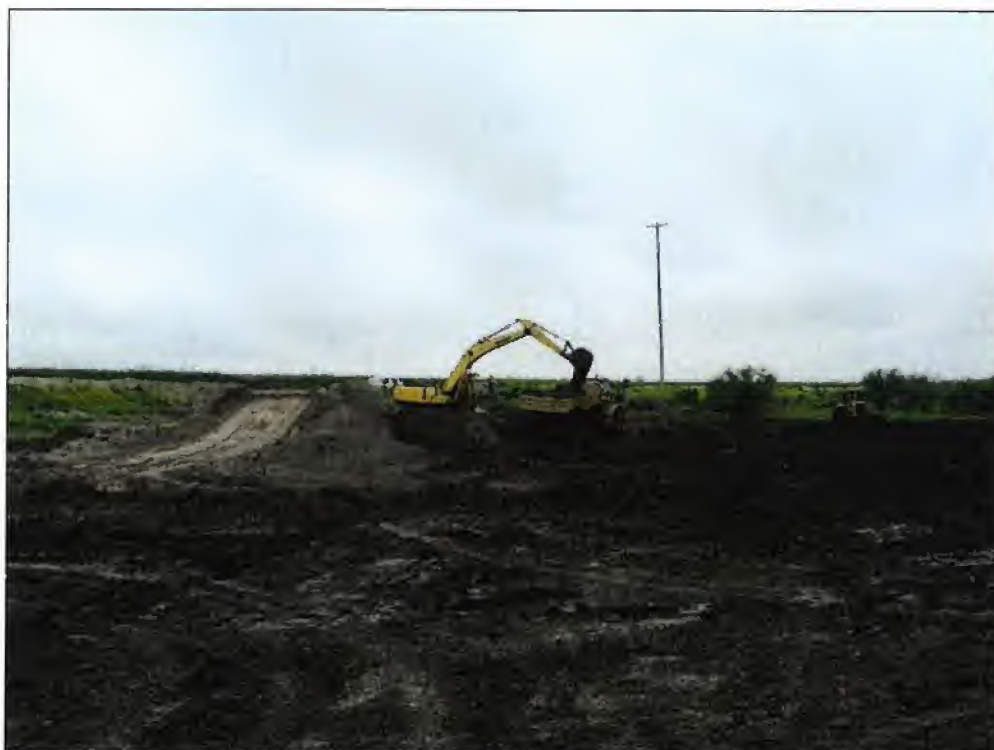
Photo 4. Equipment being utilized to remove sediment (view southwest).

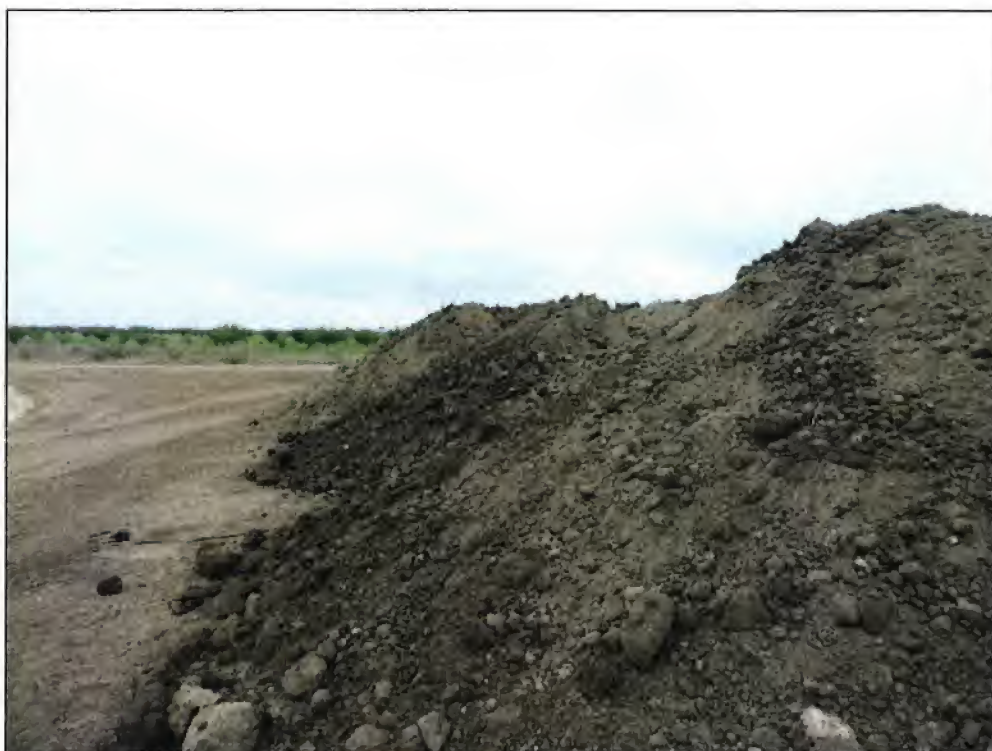
Photo 5. Excavated sediment removed from off permit affected area (view east).

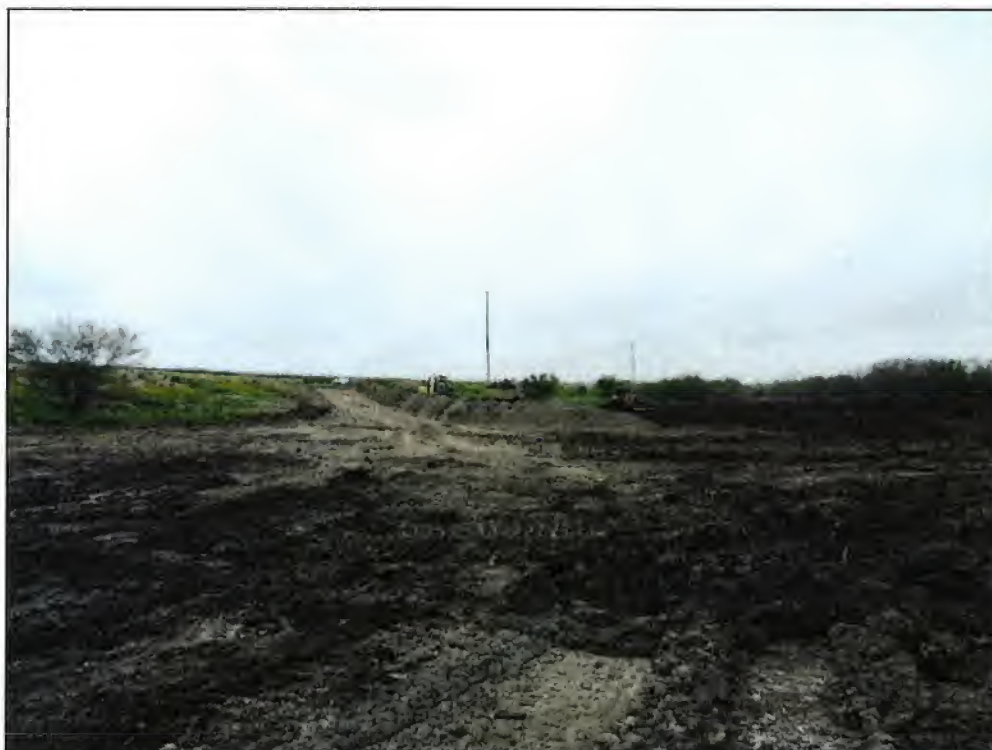
Photo 6. Approximately 1.6 acres were affected by off permit sediment deposition (view southwest).

Description of Violation(s): Failure to maintain appropriate sediment control measures. Sediment overflowed the sump along the haulroad because SMECI failed to properly maintain the sump. Therefore sediment was deposited off the permit in an area encompassing approximately 1.6 acres.

Remedial Action Required: Remove sediment from the affected area and revegetate the area.

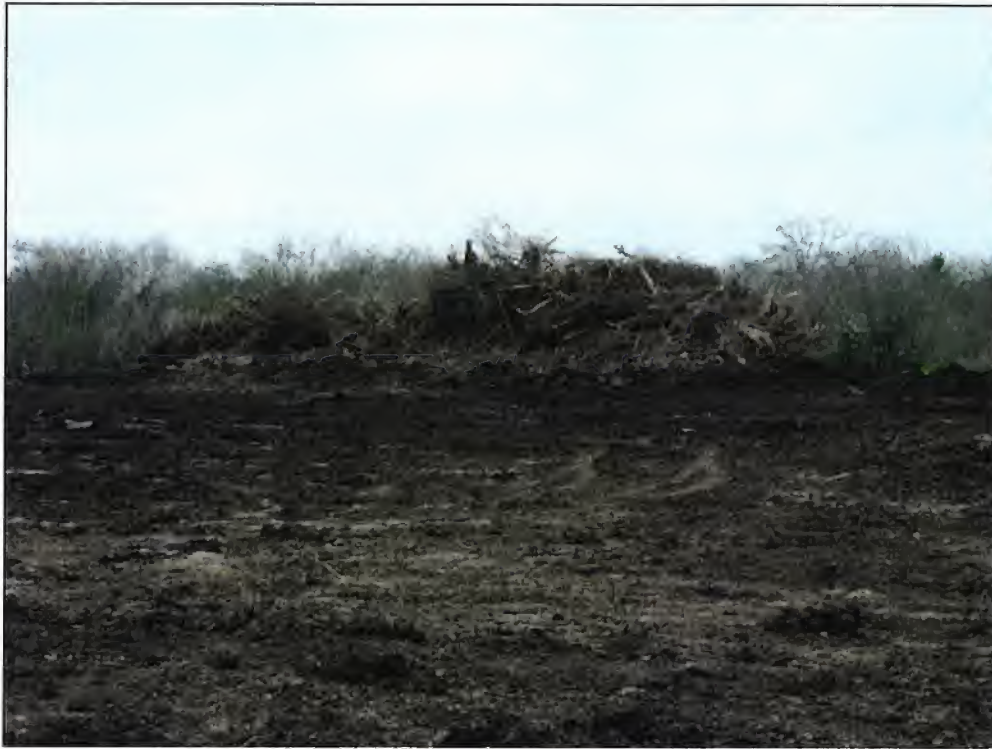
Photo 7. Removed vegetation staged west of the affected area (view north).

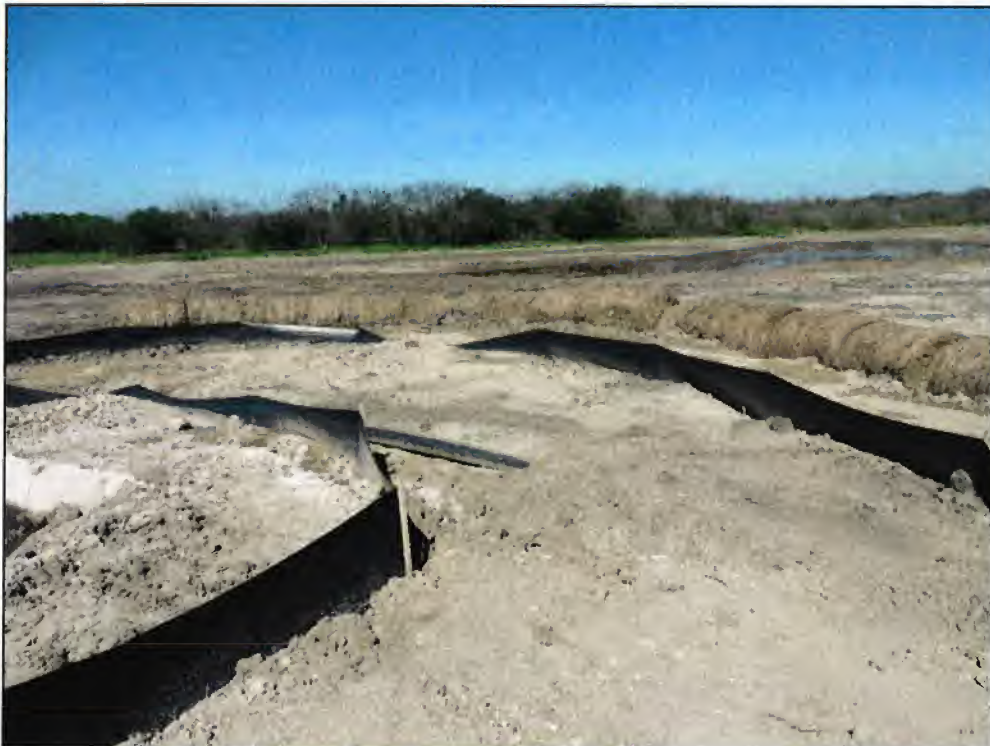
Photo 8. Silt fence and hay bales being utilized to prevent further sediment deposition (view northwest).

During my inspection on April 28-29, 2015, SMECI utilized silt fence and round hay bales to prevent further sediment deposition (photo 8). The round bales were trenched in place to prevent them from moving. The sump below Drop Structure No. BN-2 had been cleaned of debris and sediment. All sediment and vegetation was removed from the affected area (photo 9 and 10). In a follow up email with Nellie Frisbee dated May 7, 2015, all silt has been removed from the area and it was seeded for revegetation.

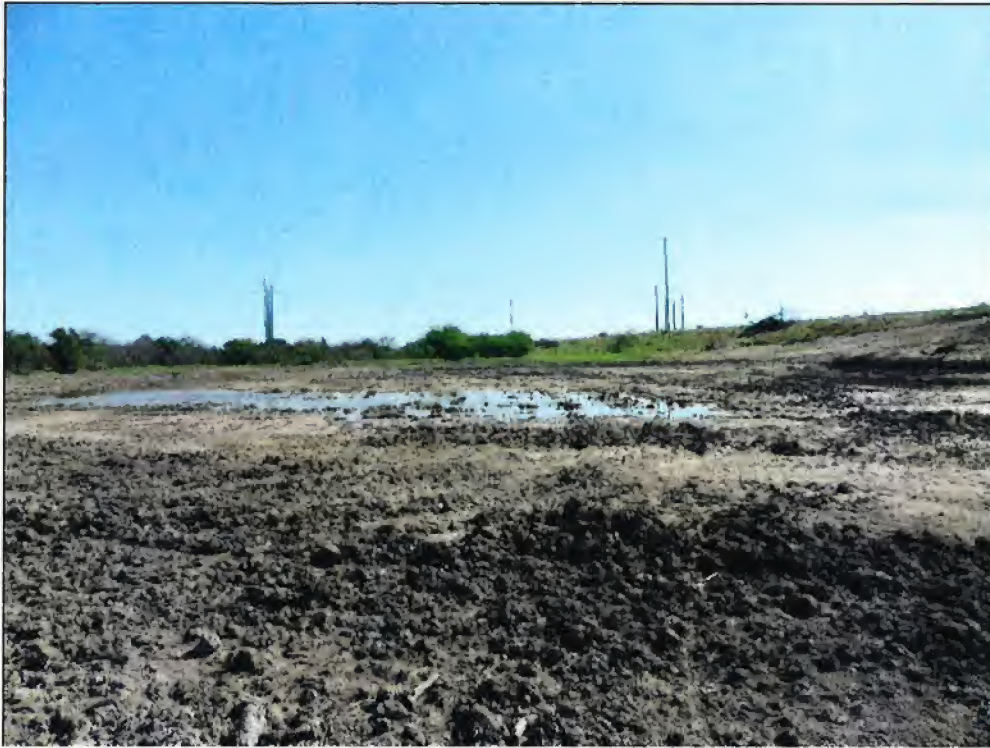
Photo 9. Sediment and vegetation has been removed from affected area (view northeast).

Via telephone conversation on the morning of May 14, 2015, Nellie Frisbee conveyed that remedial actions (silt removal, re-vegetation with landowner approved seed mix) required by NOV 114A had been completed at the San Miguel Mine. The subject area will continue to be monitored during future inspections to insure re-vegetation success, stability of the area and regular maintenance of Drop Structure No. BN-2.

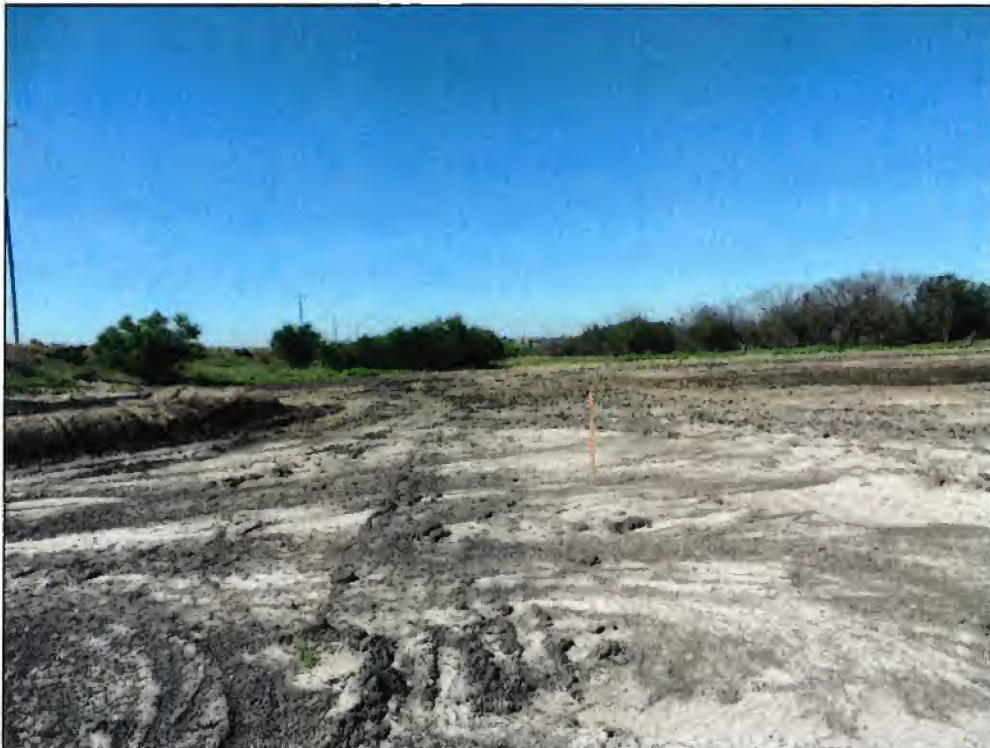
Photo 10. Affected area is now clear of vegetation and sediment (view southwest).

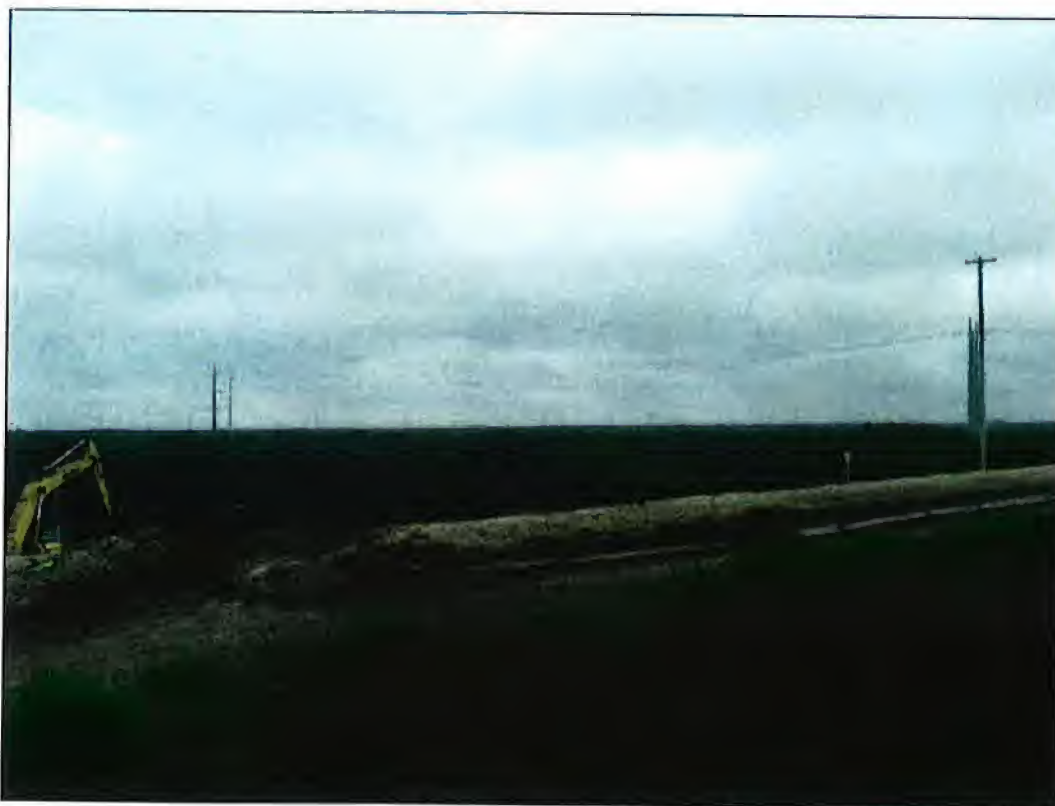
According to §12.344 **Hydrologic Balance: Siltation Structures** of the Coal Mining Regulation of Texas, (b) (1) additional contributions of suspended solids sediment to streamflow or runoff outside the permit area shall be prevented to the extent possible using the best technology currently available and (2) all surface drainage from the disturbed area shall be passed through a siltation structure before leaving the permit. After review of Permit No. 11G, and from my observations in the field, I found SMECI to be in violation of Title 16 of the Texas Administrative Code, Section 12.344 (b) (1) and (2) and section .154 of the approved permit.

Photo 4. Area of disturbance from sediment located west of the main haul road (view northwest).

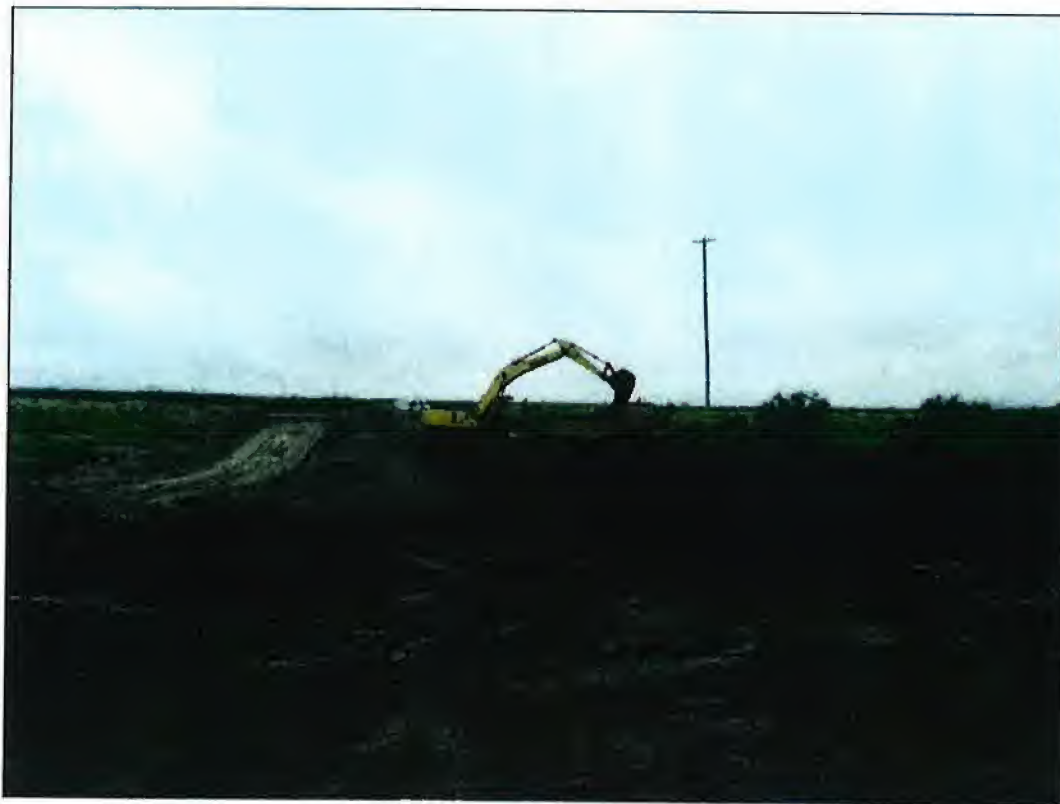
Photo 5. Excavator removing sediment from the disturbed area (view east).

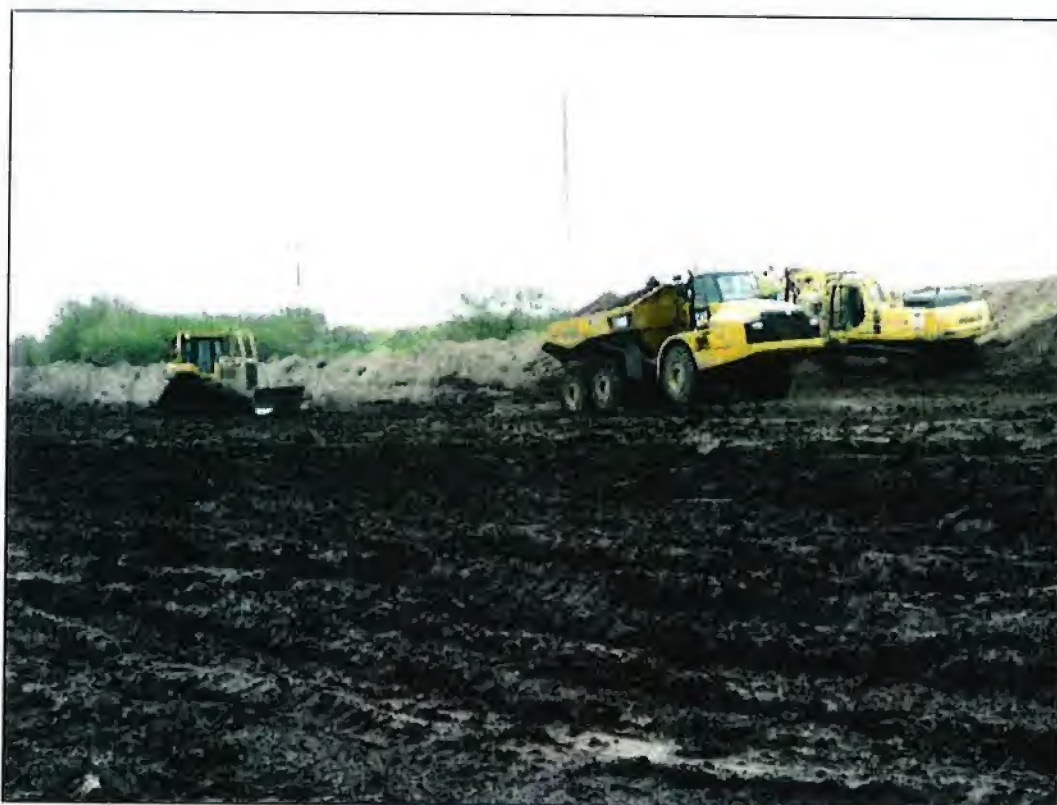
Photo 6. Equipment removing sediment in the disturbed area west of the haul road (view north).

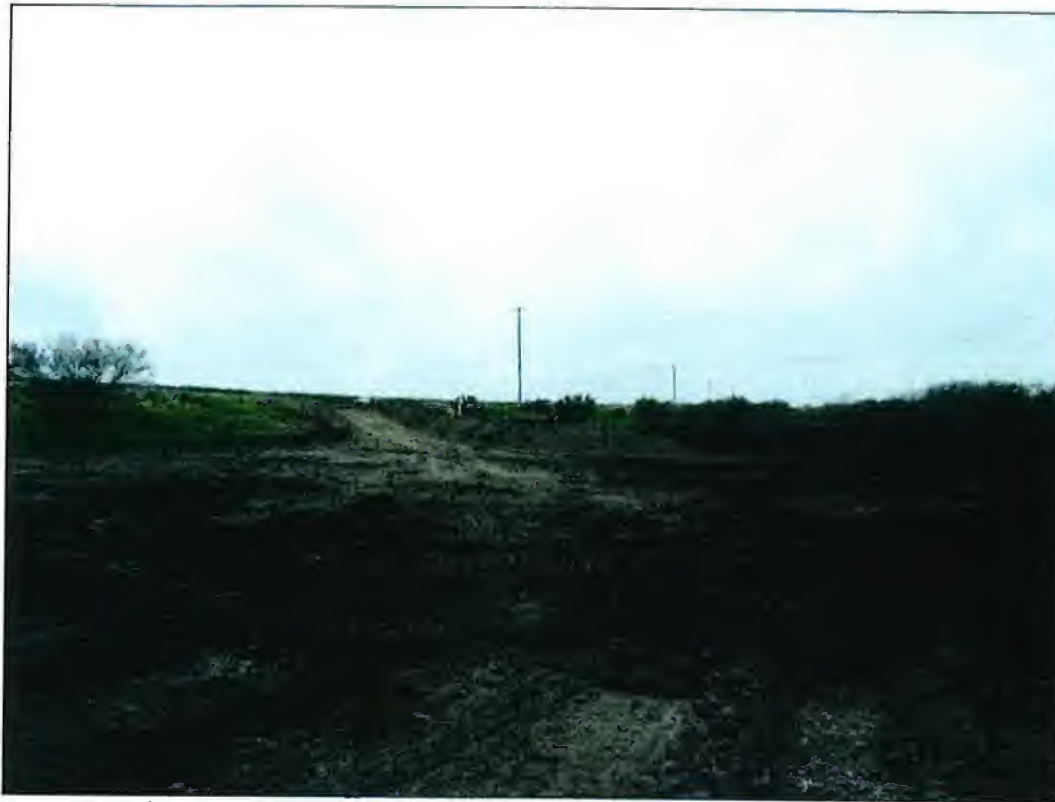
Photo 7. Sediment being removed from disturbed area (view south).

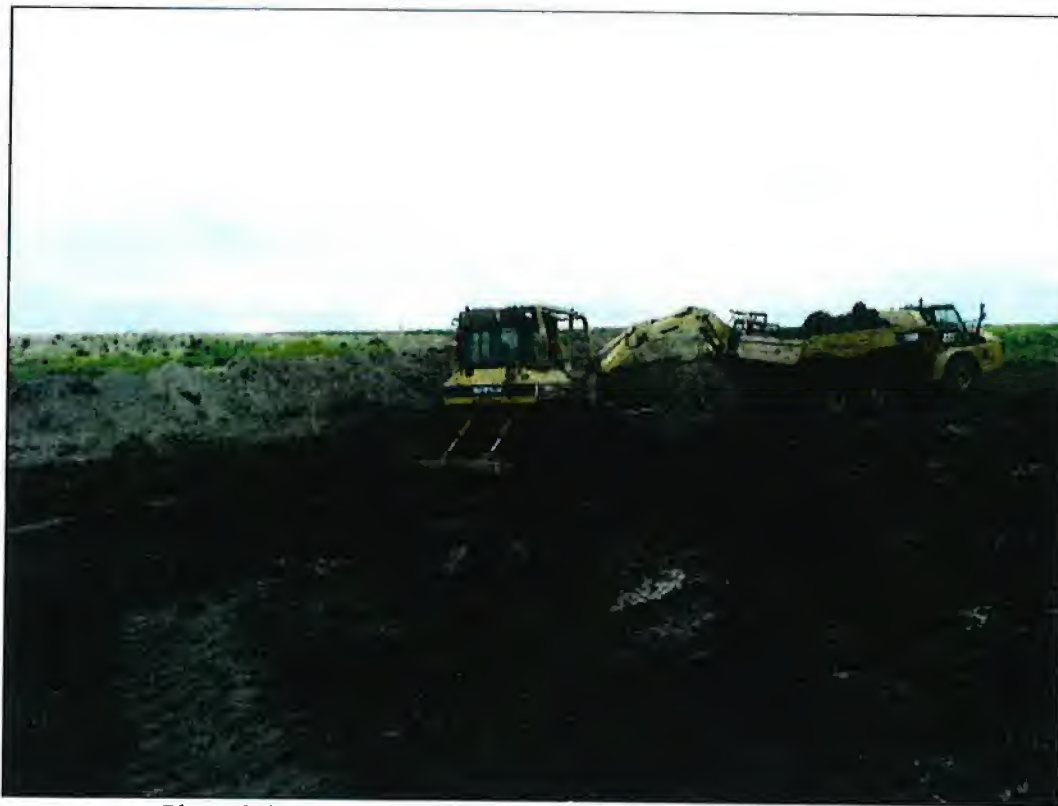
Photo 9. Dozer being utilized to level the topsoil (view south).

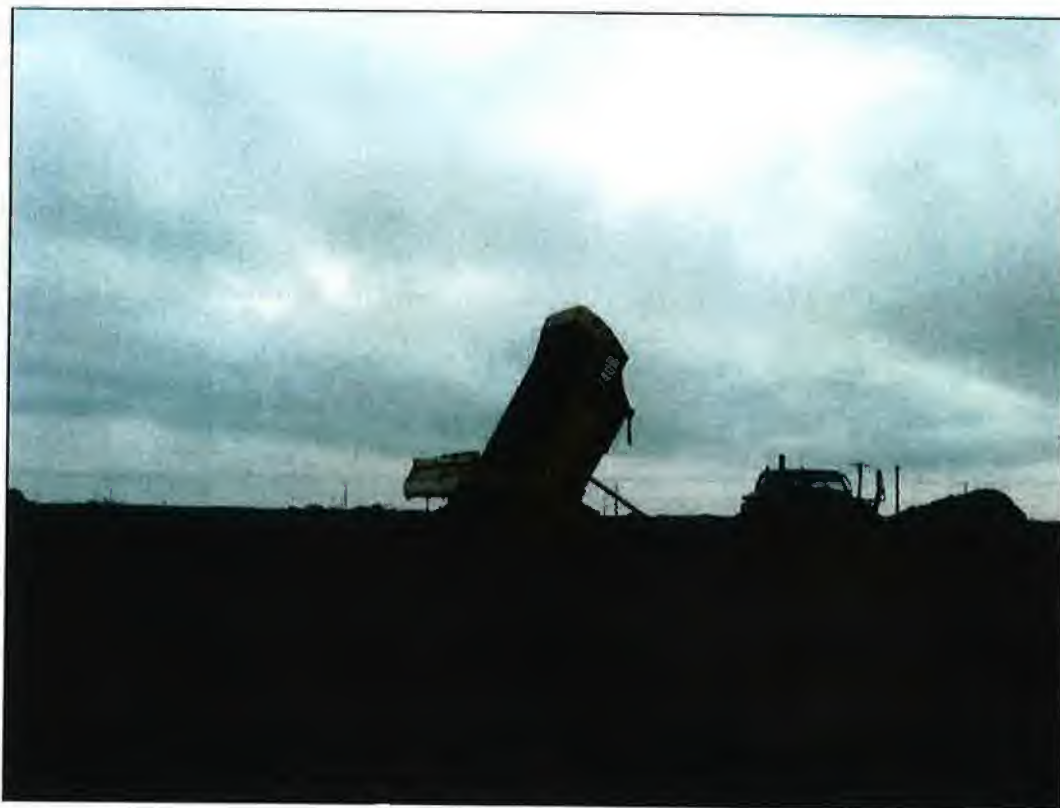
Photo 10. Sediment from the disturbed area being staged at the junction of the haulroads north of the one lane bridge (view south).

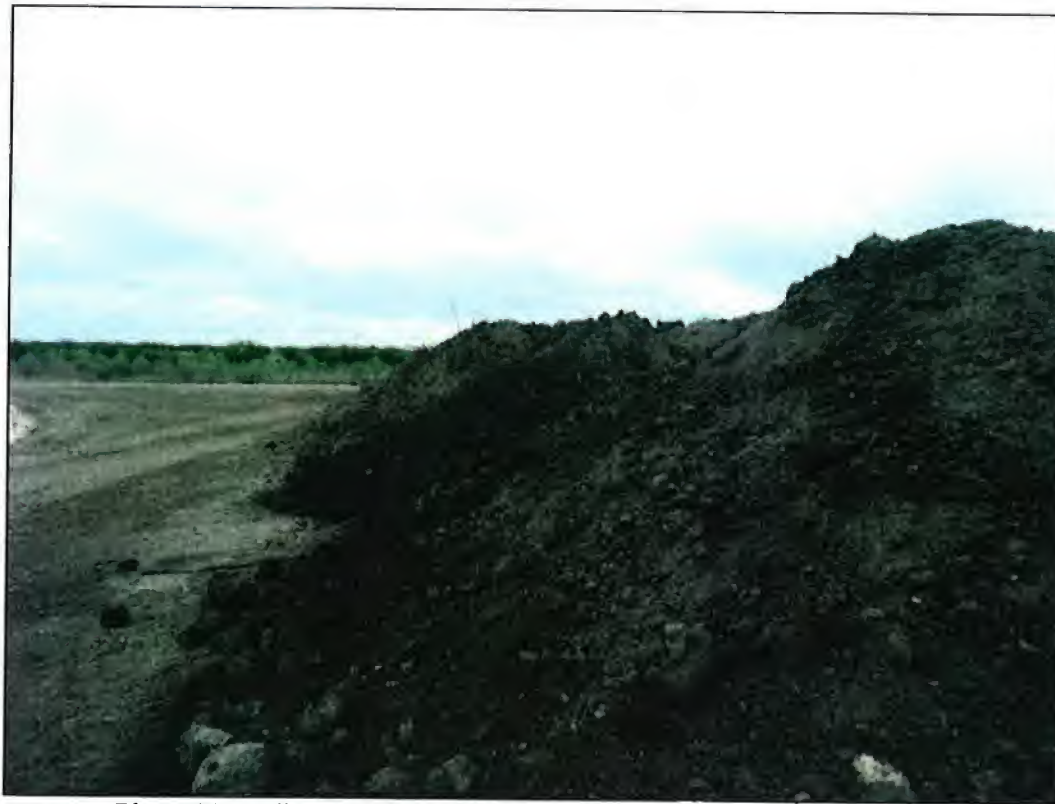
Photo 11. Sediment staged on the junction of the haulroad (view east).

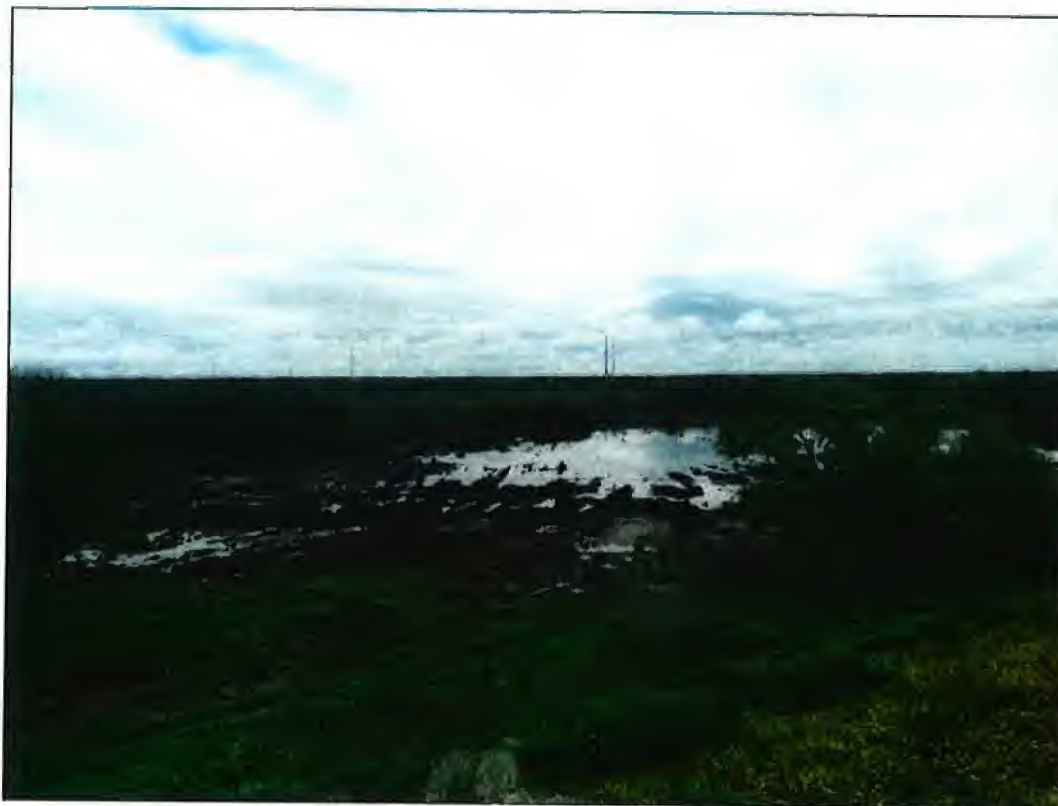
Photo 12. Disturbed area with waterlogged conditions of March 18, 2015 (view west).
